# EndurAlloy Corrosion Applications

EndurAlloy Tubing offers a unique combination of corrosion, abrasion and erosion resistance that can reduce or eliminate tubing failures for oil and gas production.

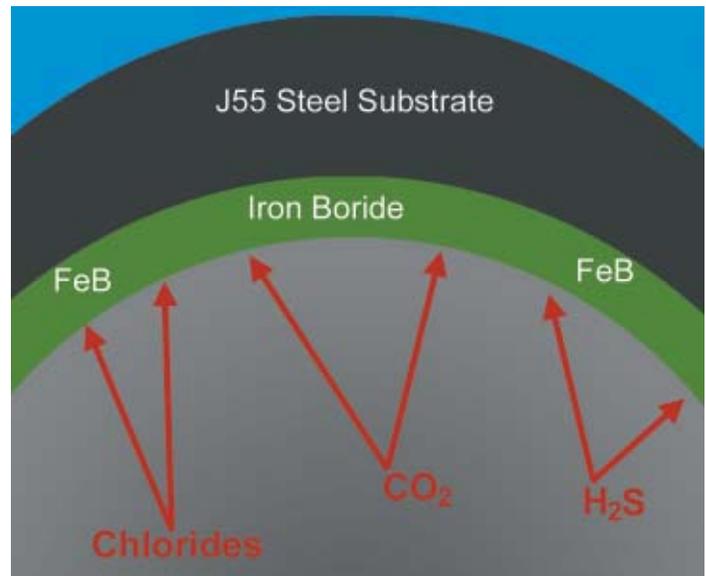
*The EndurAlloy surface is comprised of one atom of boron and one atom of iron, which combine to create a molecule of iron boride. EndurAlloy provides excellent corrosion resistance because it is inert and non-reactive to most of the corrosive elements found in oil and gas production.*

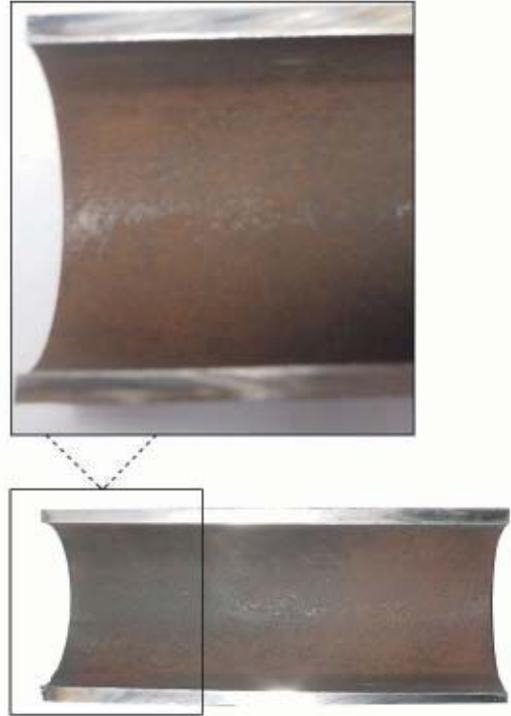
**West Texas Well**

*The section of EndurAlloy Tubing pictured above was removed from a corrosive well (H<sub>2</sub>S and bacteria) near Midland, Texas. The customer was getting two to three months from the joint above a rod pump. They installed one joint of EndurAlloy Tubing in April 2004. Six months later the tubing was pulled to replace the pump and the joint of EndurAlloy Tubing was removed for inspection. Even though it had already lasted three times the run-life of the bare steel tubing it replaced, the EndurAlloy joint showed no visible signs of corrosion or wear.*
